# **LOUISIANA DEPARTMENT OF WILDLIFE & FISHERIES**

**WATERBODY MANAGEMENT PLAN SERIES**

**LARTO-SALINE COMPLEX**

**LAKE HISTORY & MANAGEMENT ISSUES**

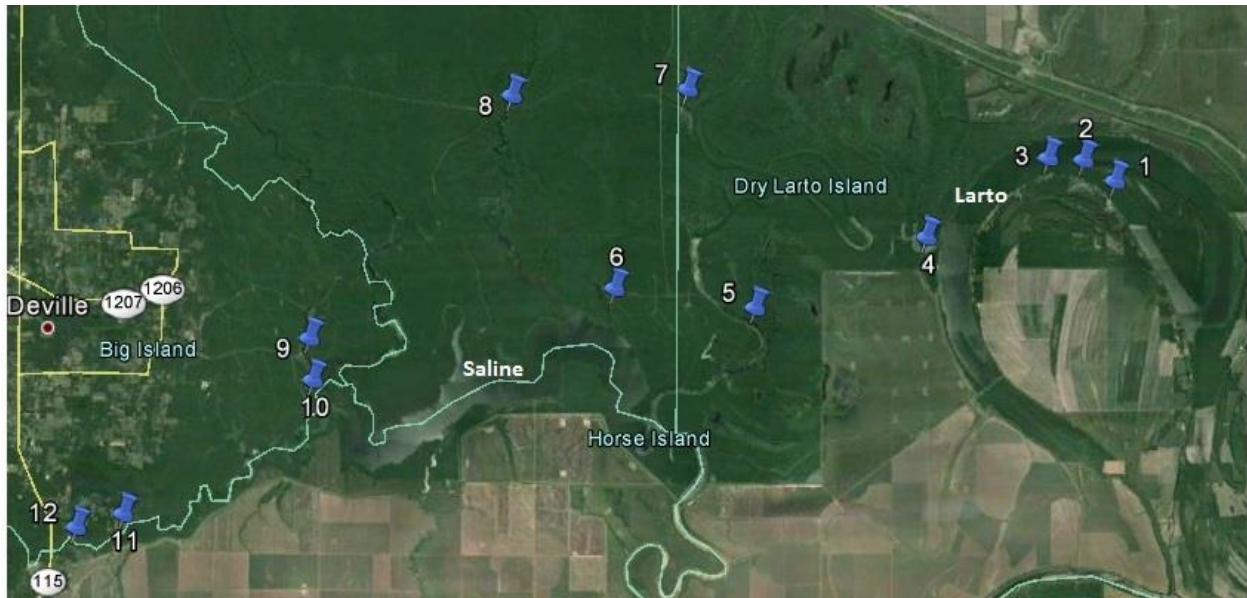
Map of Larto-Saline Lake boat ramps

1. Sander's boat landing
2. Wiley's Boat landing
3. Uncle Bud's Boat Landing
4. Youngblood Boat Landing
5. Saline Bayou Campground
6. Taylor Bayou Boat Landing
7. Phil's Landing (Cross Bayou Landing)
8. Muddy Bayou landing
9. Open Bayou Boat Landing
10. Steve's lake Landing (currently closed)
11. Woodson Landing
12. Big Creek Boat Landing

Map with access locations in [Appendix I](#).
